# MANDATORY Service Bulletin Fuel Systems

Bulletin No.: PEX-1  
Revision No: 1  
Date: 3/24/08

**SUBJECT:     HEX PLUG 383493 COMING LOOSE FROM REGULATOR COVER**

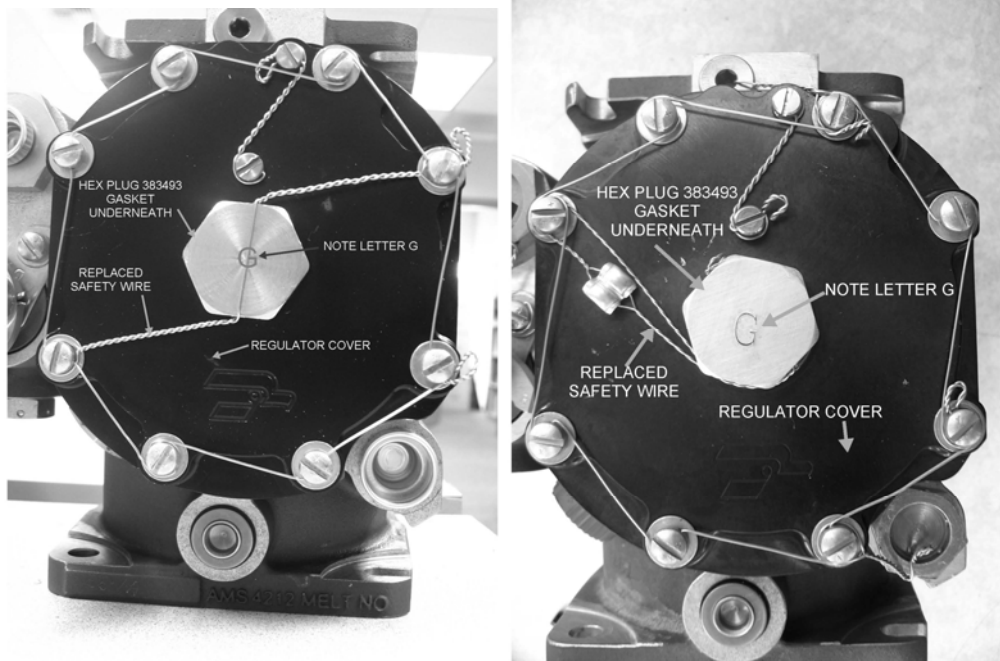
Note: The safety wire through the hex plug shown in the left hand photo is .025" wire wrapped around regulator screws under existing wire. It does not go through the holes in the screws. The safety wire through the hex plug shown in the right hand photo is .015" wire which passes through the regulator screw hole. This is the normal safety wire method used at the factory.

**IMPORTANT:** The letter "G" shown in the photos is to be stamped **ONLY** if the new gasket, part number 2577258 has been installed.

6. With an acceptable hex plug, an acceptable regulator cover, and an acceptable gasket, install the gasket over the hex plug and install plug into the regulator cover. Torque the hex plug to 90-100 in-lbs.
7. The hex plug must be safety wired with .015 or .025 inch diameter wire to the regulator cover as shown in the photos below. The wire shall pass thru the plug such that it pulls the plug in the tightened direction and does not rest on the corners of the hex on the plug (it is acceptable to wrap under the corners of the hex plug). These photos are just two examples of acceptable safety methods. Other safety methods such as those described in FAA AC 43-13 are also acceptable.
