Service Information Letter - Fuel Systems

RSA-5AD1

**SUBJECT: Rework Instructions for RSA-5AD1 Fuel Injection Servo
Installed on Slingsby T-3A Aircraft.**

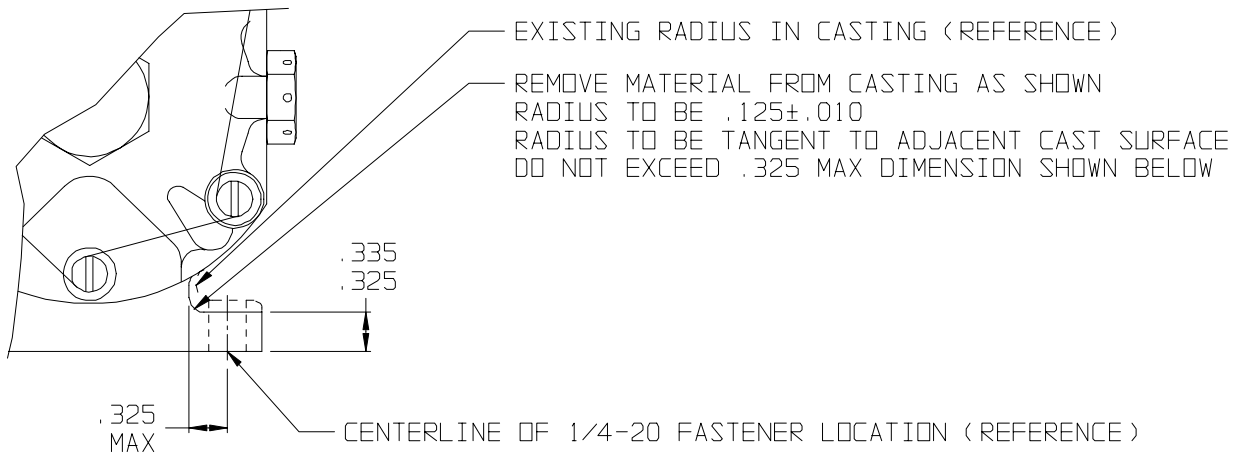
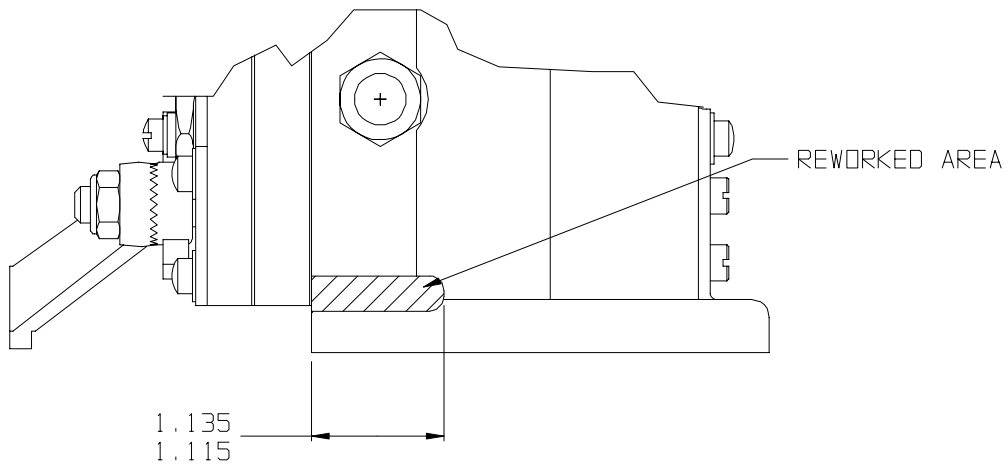
Figure 1

- B. **DESCRIPTION:** On Slingsby T-3A aircraft a throttle cable support bracket is installed on the back side of the airbox mounting flange on the throttle body. In some cases there is insufficient clearance for this bracket. The throttle body on the affected fuel injection servos may be reworked per this letter to allow installation of the bracket.

3. Remove material as indicated by Figure 1. Material removal must not exceed the dimensions shown. Reworked area shall be blended smoothly into surrounding area. Surface finish must be RHR 125 or better.
