Service Information Letter - Fuel Systems

SIL RS-59 Revision 2

RSA-5AD2

SUBJECT: 2576540-4 and 2576540-5 Throttle Friction

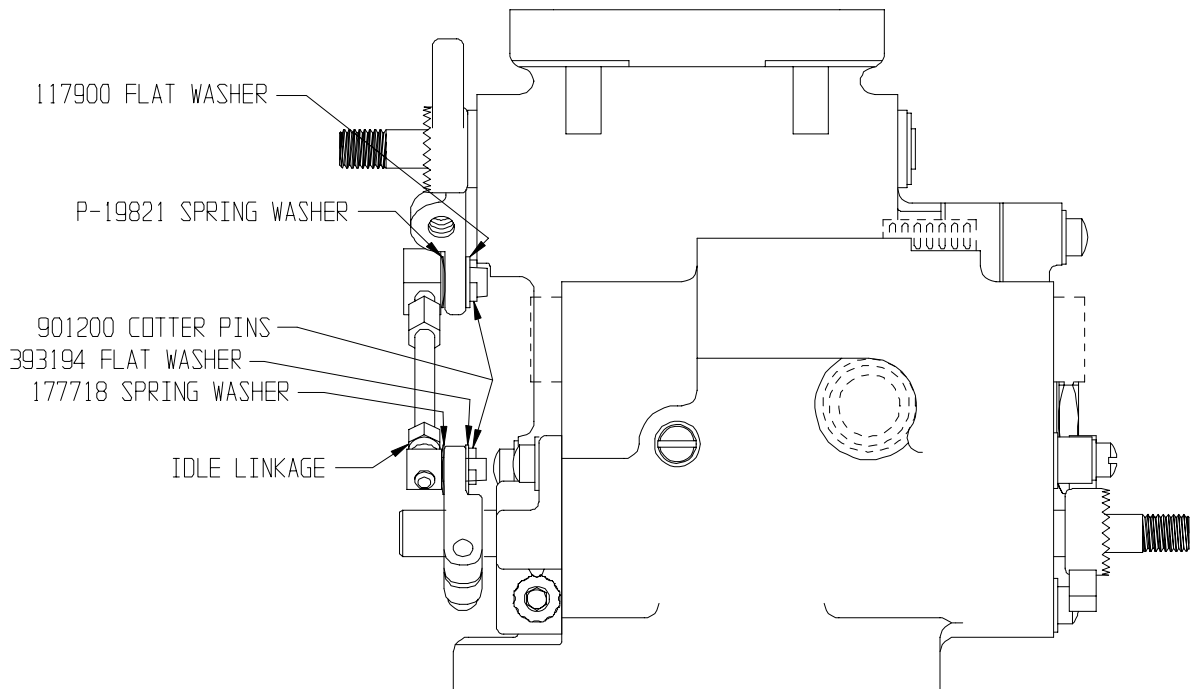
Figure 1 RSA-5AD2

- C. INSPECTION PROCEDURE:** If your aircraft has a 2576540-4 or 2576540-5 fuel injection servo and if the throttle movement is excessively stiff or rough (with the throttle friction off), inspect the idle lever assembly on the RSA-5AD2 fuel control servo for excessive friction. Disconnect the idle mixture linkage at the idle lever arm and throttle arm by removing the cotter pins; be sure to save the flat washers and spring washers for reassembly (see Figure 1). Rotate the idle lever by hand; if the lever action catches, grabs or the force measured directly on the linkage using a linear scale exceeds 4 lbs the servo should be reworked. Insure that measurements are taken perpendicular to the arm of the lever to obtain an accurate reading. The servo should be removed and replaced with a 2576540-7 fuel injection servo.
